## **Library Accessibility Information**

# UIC Library Audit

## Overview of UIC Library:

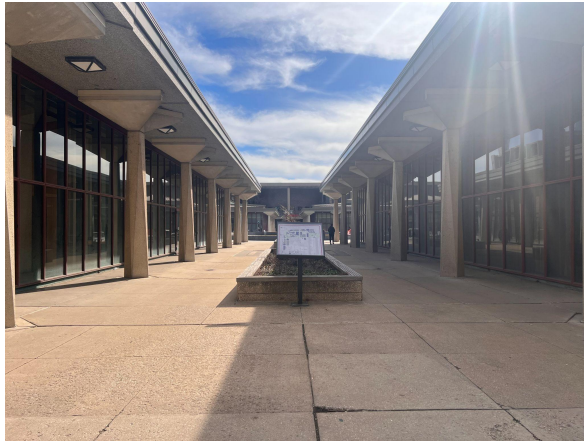
spacious concrete. As the individual makes their way to the UIC Library, they may encounter some holes and bumps in the concrete.

- **Note:** There was still some construction going on on the side of the quad. The ground where the quad was made is smooth concrete, but surrounding this part, there are holes and bumps in the ground. Additionally, the quad does not have any roofing, which means there will be no covering during the rainy/snowy/hail weather.

Image Description: (Left) Uneven and cracked concrete alleyway with buildings and polls on either side. A sign in front of an elevated garden is placed within the center of the alleyway. (Right) Wide walkway leading to the Quad. The SCE building is seen far ahead.

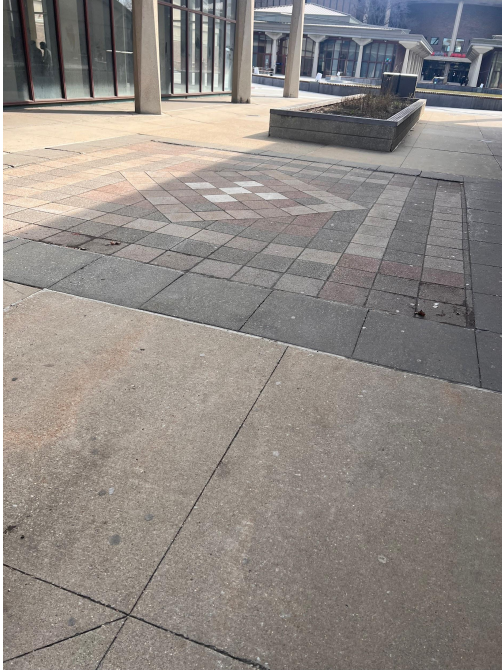
Image Description: Very textured and uneven concrete pattern on an alleyway in front of an elevated garden space. Buildings in the background on the top of the image.

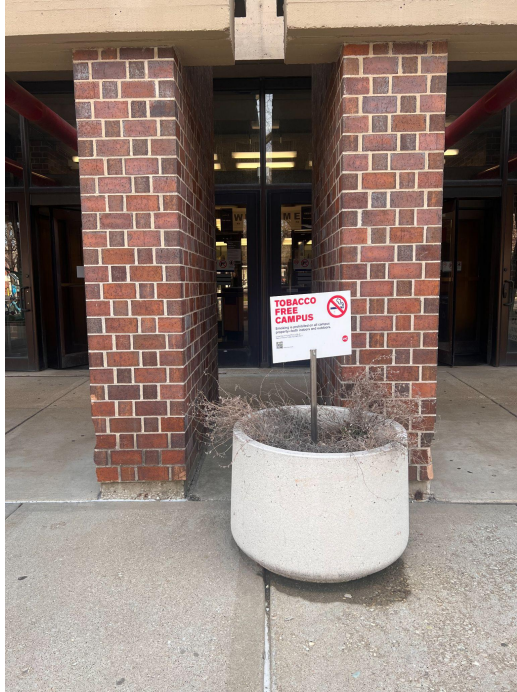
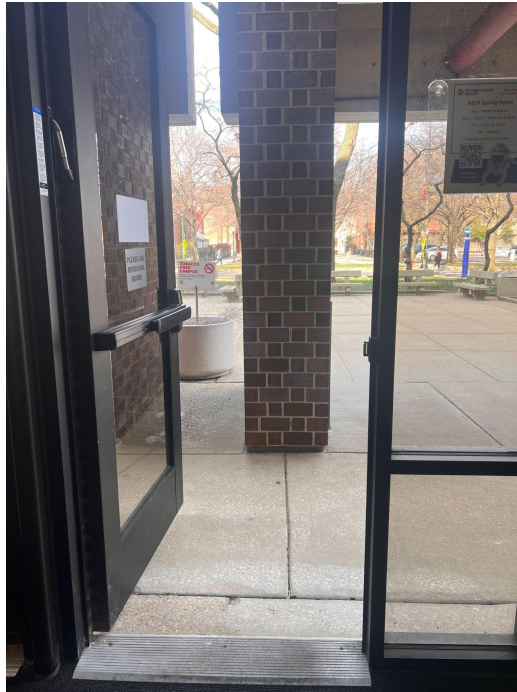
- When entering from Morgan Street, there are 4 sets of doors, two revolving and two accessible doors. The revolving doors are placed on the outer sides of the buildings with both accessible doors being placed in between. There are two large pillars in front of the accessible doors with an accessible button on the side of them.

- **Note:** With large scaled events or busy hours, the area may get congested and may be difficult to access the accessible doors for some individuals. On another note, the accessible doors all opened smoothly and efficiently.

Image Description: (Left) Two brick pillars and a large planter stand in front of a set of doors. (Right) an open accessible door reveals a brick pillar standing four feet from the entrance.

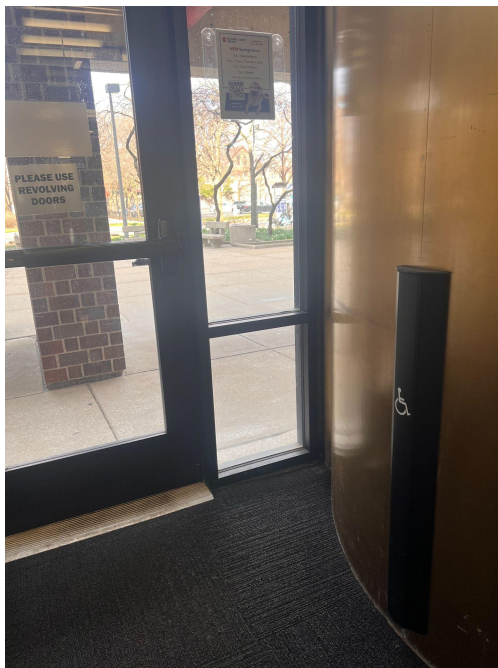
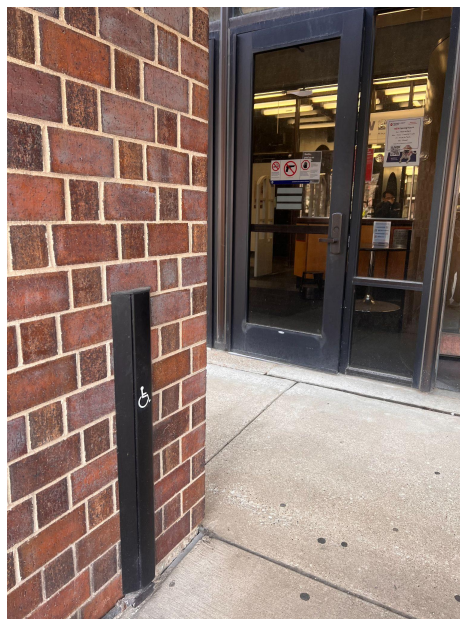
Image Description: (Left) A closed accessible door with an accessible push button propped onto a wall to the right of the image. (Right) A closed accessible door accompanied by an accessible push bar located to the left of the screen onto a brick wall.

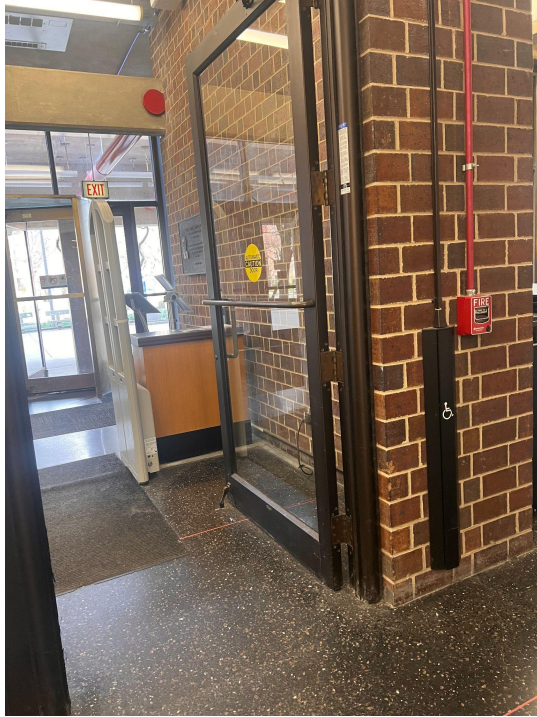
- **Note:** At the time of the audit, the only door that was opened was the accessible door on the left side, which can cause congestion during busy hours. On another note, the accessible doors all opened smoothly and efficiently.

Image description: Accessible door is open leading to a set of metal detectors and a second set of revolving exit doors. Accessibility push button is prompted onto the brick wall beside a fire alarm.

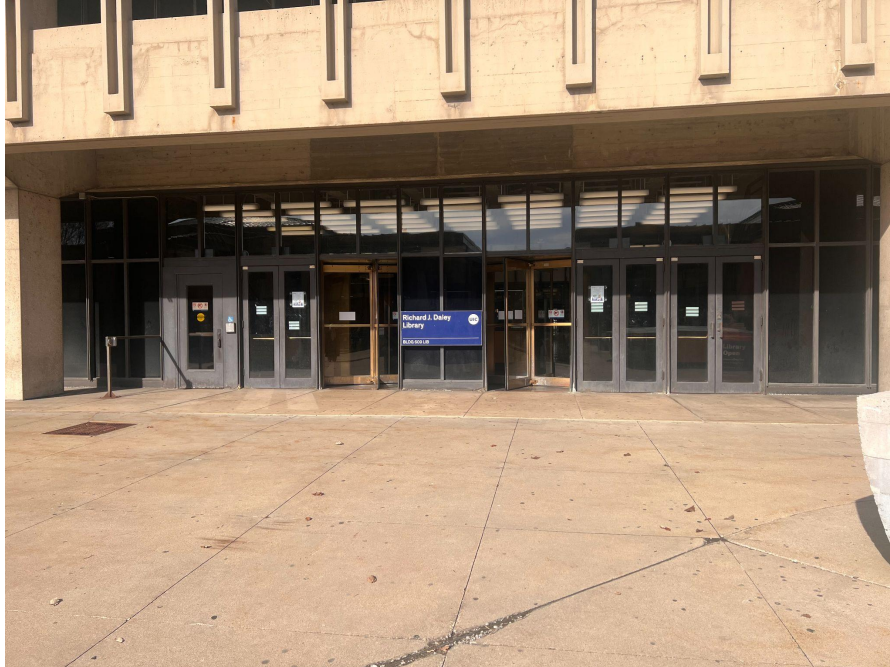
Image Description: Six entrances in total, two sets of doors on either side of two revolving doors. The door furthest to the right is the accessible door with the accessible push button. The concrete ground is textured and cracked.

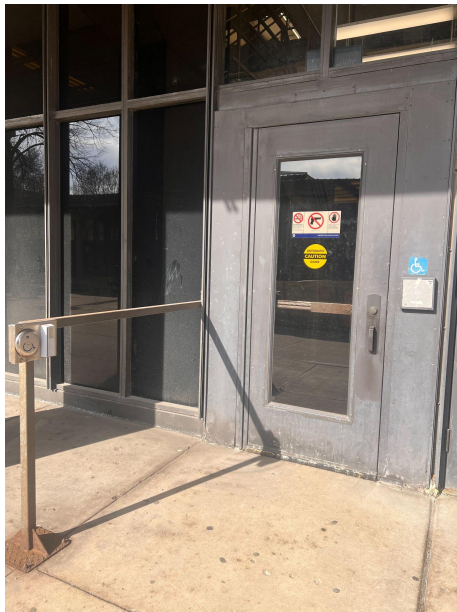
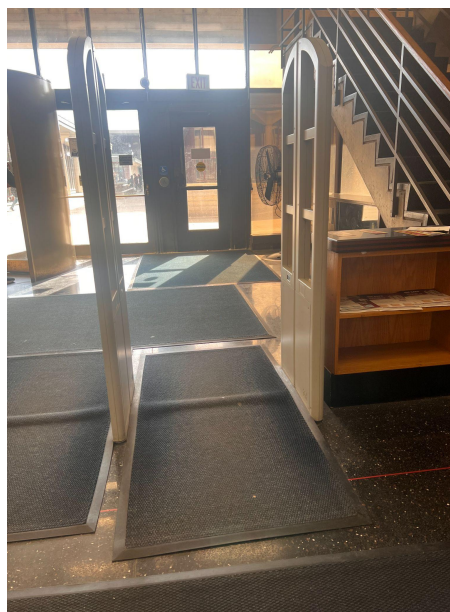
- The library's entrance has metal detectors with one bump on the ground at each detector. After passing the detector, there are 6 doors that are propped open with one accessible door on the left side. The library opens up with a bright light, and smooth, non-carpeted ground. UIC's Library is spacious and there are many different signs as well as colors being posted all around the library; however there are no signs to distinct what room is which. There was no specific scent or loud signs.
  - **Note:** The description is based off the entrance from SCE/Quad. The library is overall very spacious, even with posters/signs, these were along the sides of the wall and allowed for spacious pathways.

Image Description: (Left) Accessibility door accompanied by an accessibility button elevated to the left of the image. (Right) 2 paralleled metal detectors standing five feet away from the accessible entrance to the library. Carpeted floor is not leveled with a bump between the two standing detectors.

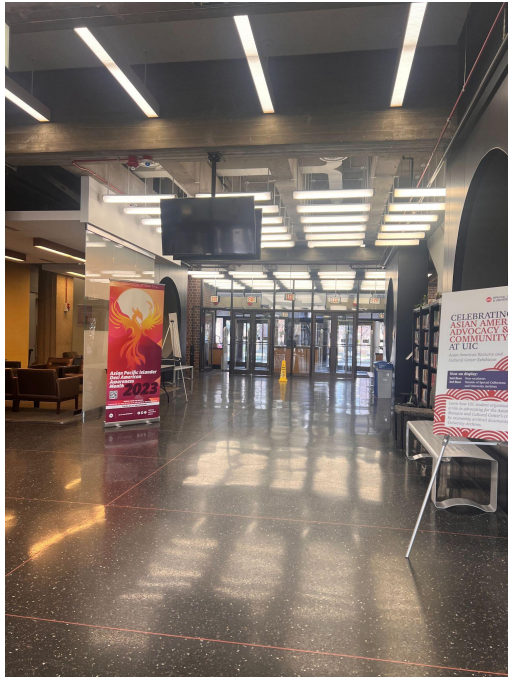
Image Description: Spacious, wide, leveled, smooth floors of a hallroom. Two large colorful posters on either side of the image along with the set of doors. Seating spaces are placed on either side of the hall. Fluorescent lights rods hang on the ceiling along with two monitors.

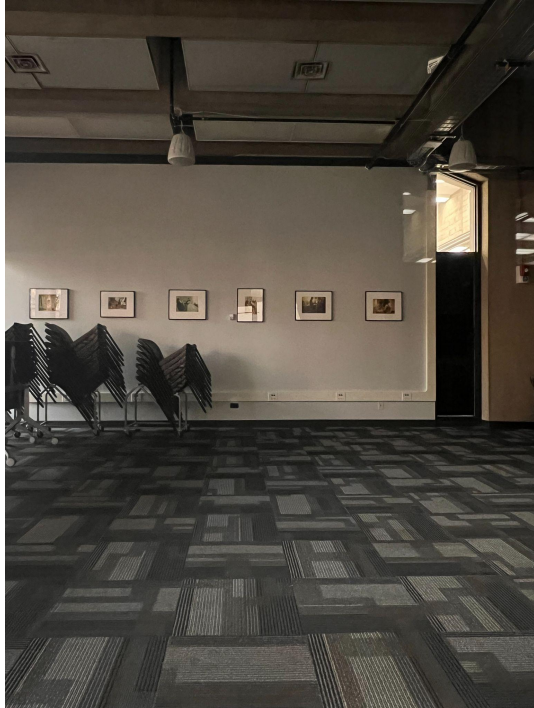
- In order to enter Room 1-470 from the main SCE entrance, individuals must turn right, go straight down and make a left turn and the room will be in a corner. The room specifically does not have an accessible door. The door is approximately 35 inches wide. The room has a large window in the back and side, which shows carpeted ground. The room number does not offer brail.
  - **Note:** The room was locked this day, so the audit is based off of observations through the window. Additionally, the room was not set up for the event, so the audit does not reflect what the room will be on the day of the event.
  - **Note:** Since there are no signs to figure out where the room is, this can be challenging for some individuals to find, but there are workers individuals can always ask.

Image Description: Dim spacious hall with carpeted floor throughout. Set of paintings hung onto the walls along with sets of chairs stacked onto one another toward the left side of the image.

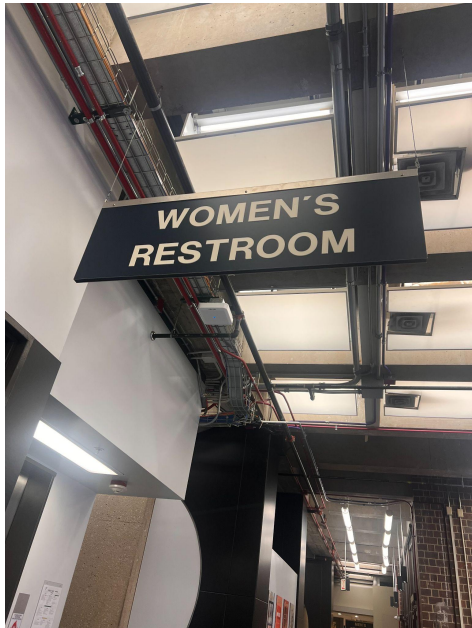
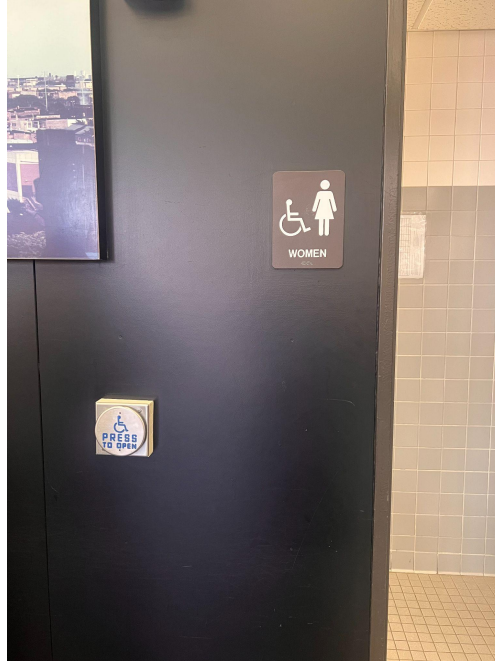
Image Description: (Left) Sign reads “Women’s Restroom” hung from the ceiling. (Right) Women’s restroom sign, accessible with braille, posted beside the entrance, accompanied by the accessibility push button below it.

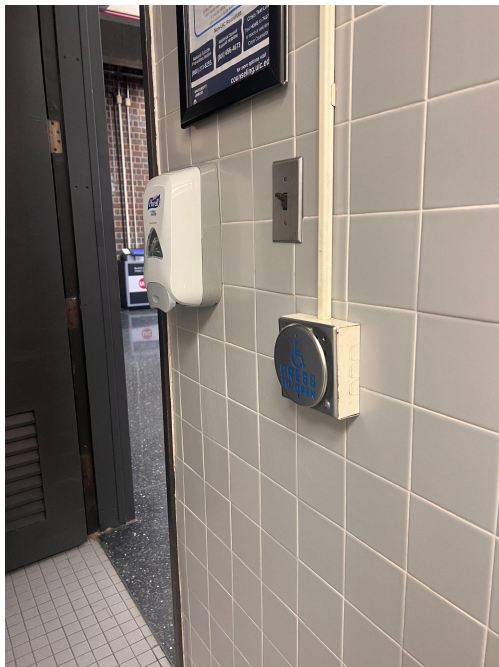
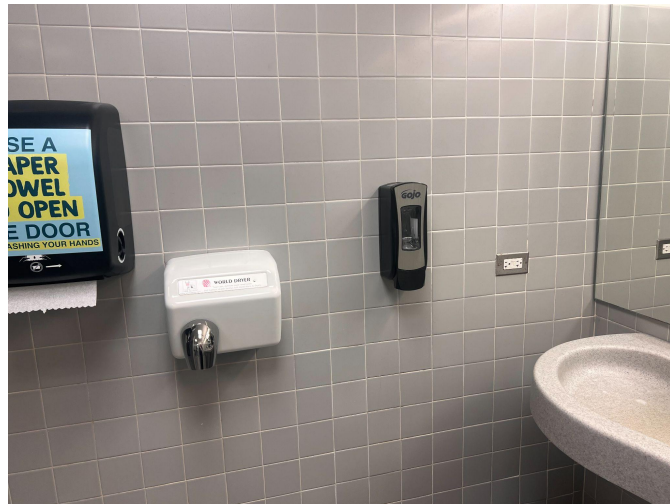
Image Description: (Left) Women’s bathroom exit, accessibility push button hung on the tiled wall beside a lightswitch and hand sanitizer dispenser near the exit. (Right) Towel dispenser, drier, and soap dispenser hung on a tiled wall beside a sink.

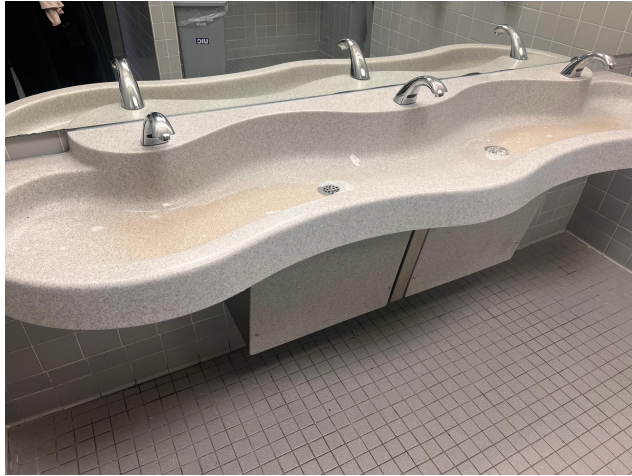
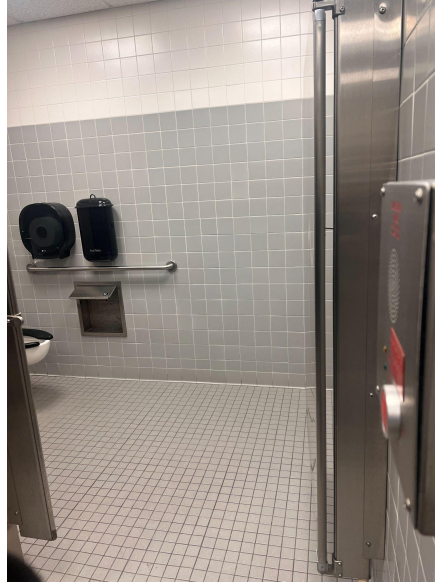
- The bathrooms are located right down the hall from Room 1-470, with a large sign saying “Women’s Restroom.” The women’s restroom has an accessible button as well as brail on the sign. The entrance width is approximately 41 inches. Upon entrance, the individual is greeted with a horizontal mirror as well as a rollover low, connecting sink. The sinks are automatic and there are soap dispensers located on both sides of the walls. After turning right, there is a pathway to the different stalls with one accessible stall at the end of the path. The entrance to the accessible stall is about 36 inches wide, and the stall size is about 67” x 100”. There are also two handle bars. In the pathway of the stalls, there is one emergency button.

Image Description: (Left) A floating three compartment sink in front of a large mirror, leveled above tiled floors. (Right) Entrance to the accessibility bathroom made of tiled walls and floors. Emergency call button hung to the right of the screen outside the stall. A pull bar, toilet paper dispenser, and trash bin are hung within the stall beside a toilet.

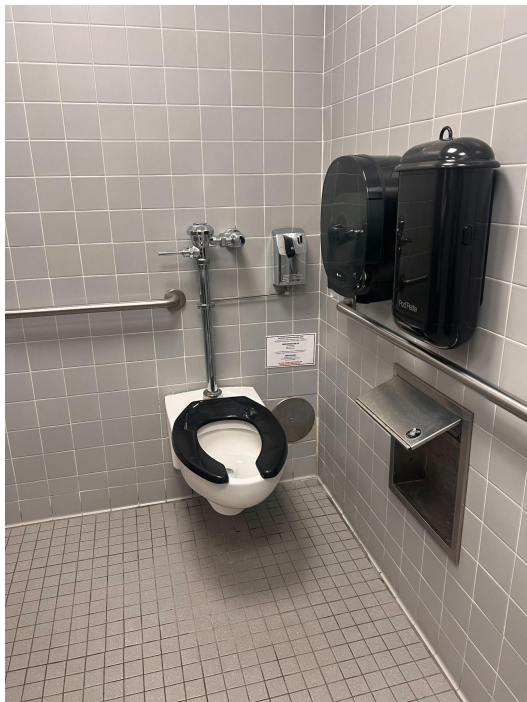
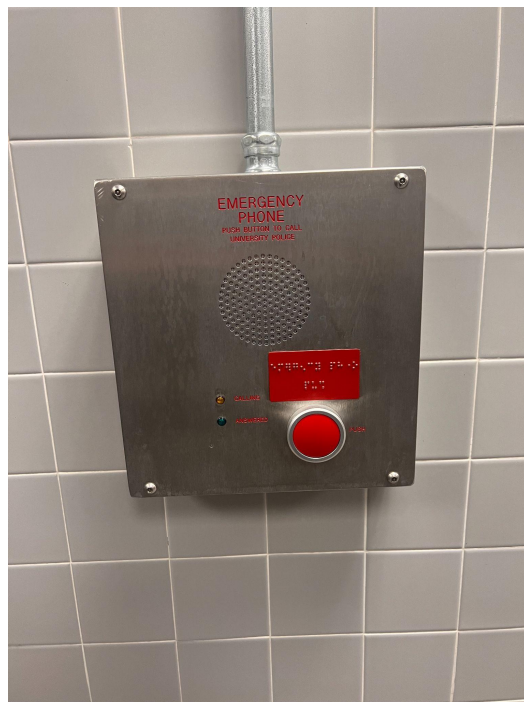
Image Description: (Left) Toilet placed between two pull bars on either side. To the right of the toilet a toilet paper dispenser, and trash bin are propped above the pull bar. The walls and floors are tiled. (Right) Emergency phone and button hung onto a tiled wall.

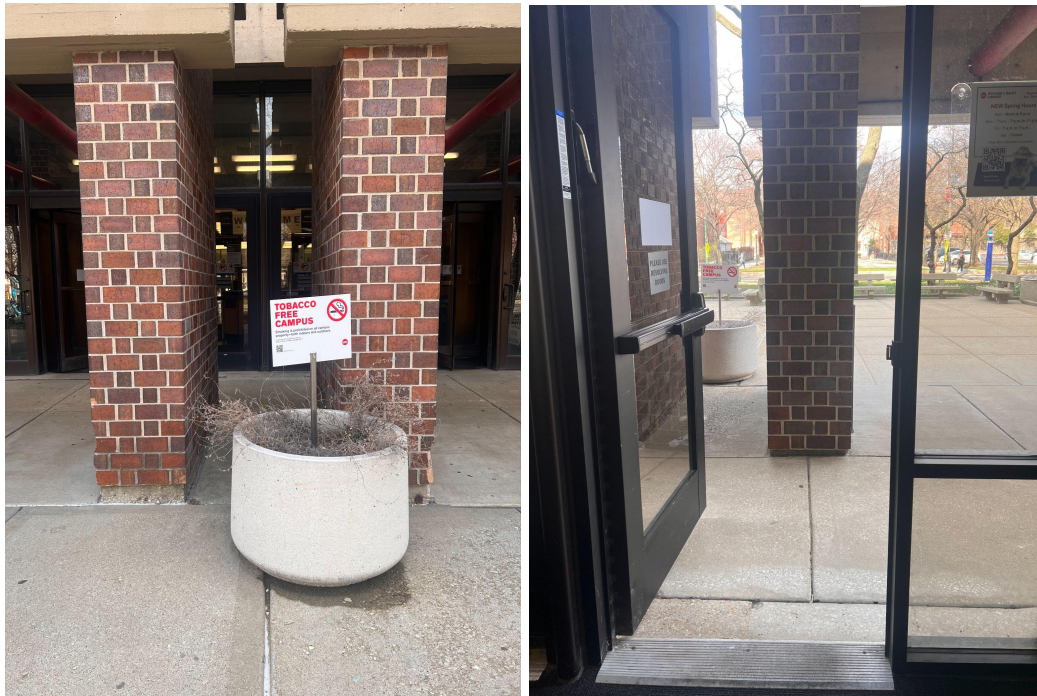
Image Description: (Left) Two brick pillars and a large planter stand in front of a set of doors. (Right) an open accessible door reveals a brick pillar standing four feet from the entrance.

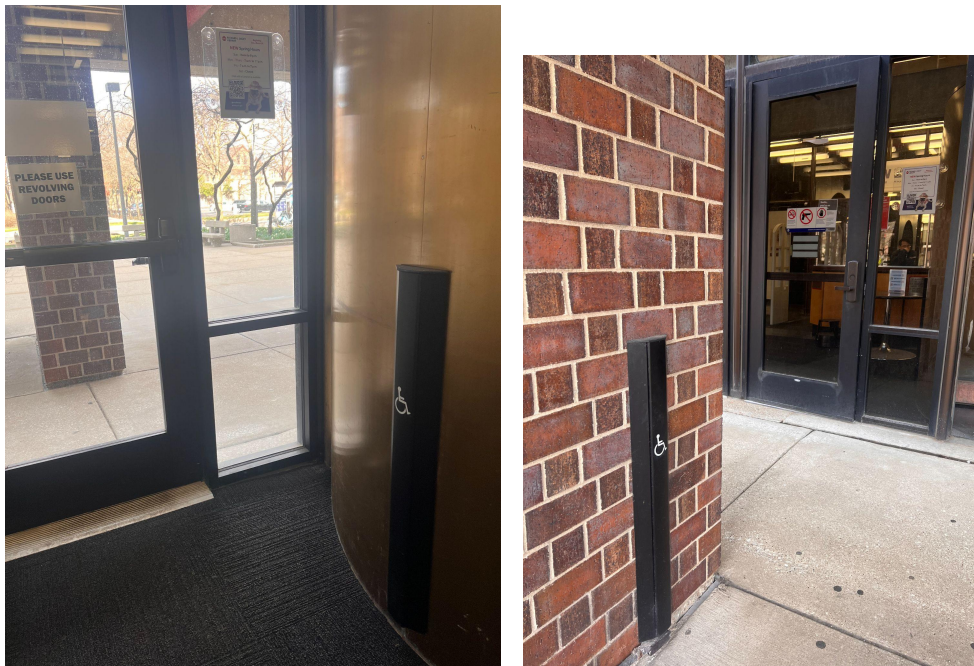
Image Description: (Left) A closed accessible door with an accessible push button propped onto a wall to the right of the image. (Right) A closed accessible door accompanied by an accessible push bar located to the left of the screen onto a brick wall.

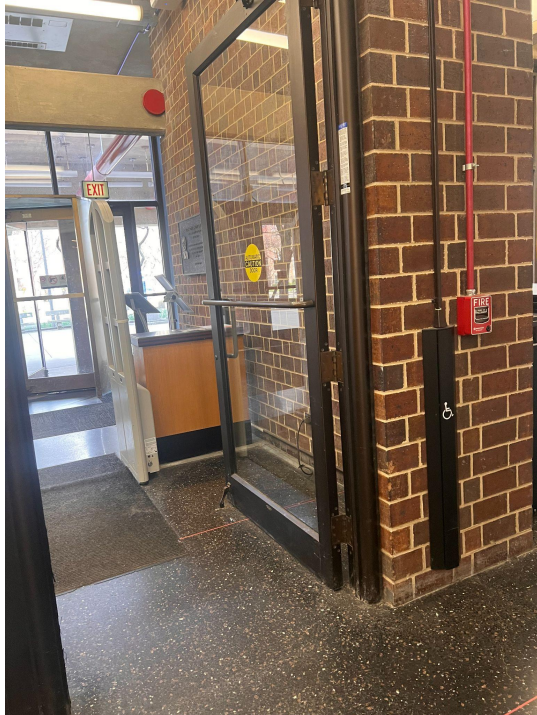
Image description: Accessible door is open leading to a set of metal detectors and a second set of revolving exit doors. Accessibility push button is prompted onto the brick wall beside a fire alarm.

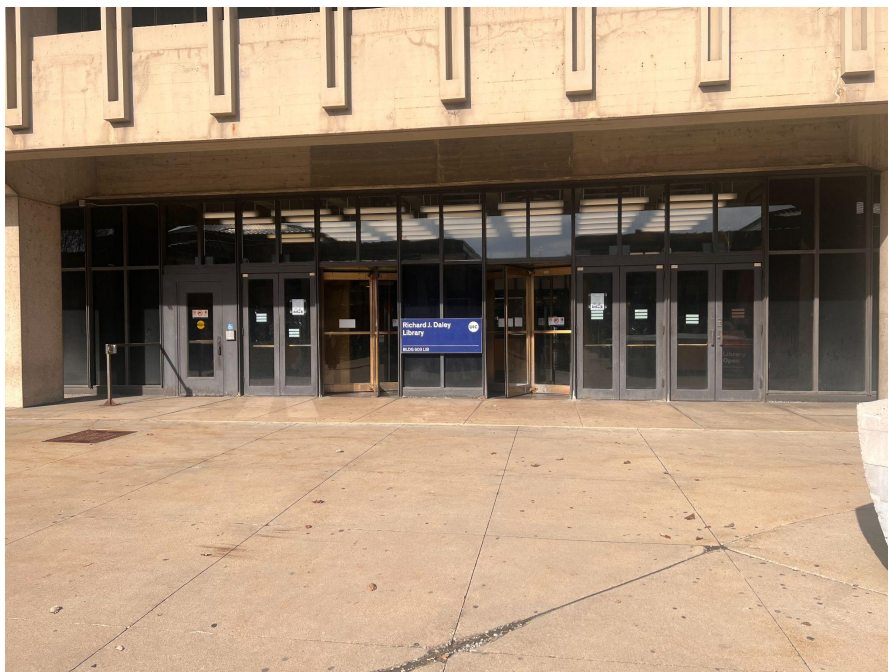
Image Description: Six entrances in total, two sets of doors on either side of two revolving doors. The door furthest to the right is the accessible door with the accessible push button. The concrete ground is textured and cracked.

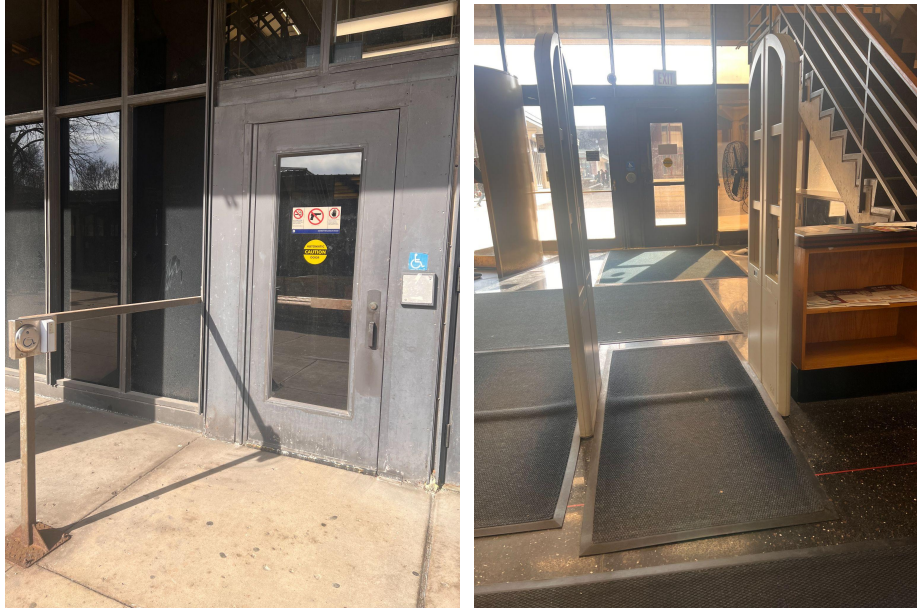
Image Description: (Left) Accessibility door accompanied by an accessibility button elevated to the left of the image. (Right) 2 paralleled metal detectors standing five feet away from the accessible entrance to the library. Carpeted floor is not leveled with a bump between the two standing detectors.

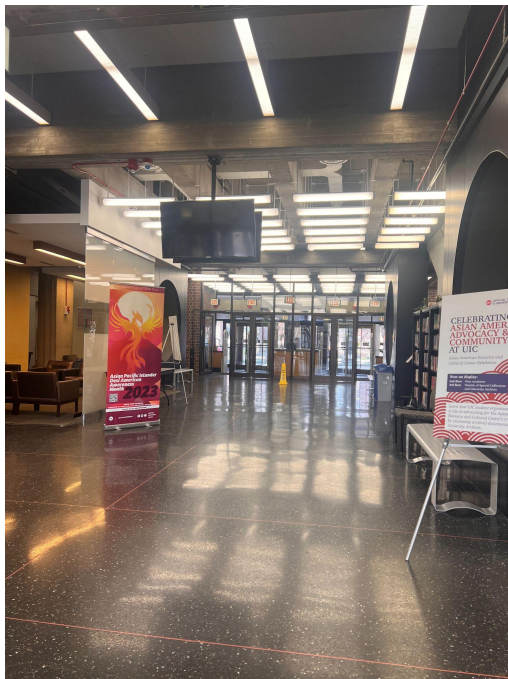
Image Description: Spacious, wide, leveled, smooth floors of a hall. Two large colorful posters on either side of the image along with the set of doors. Seating spaces are placed on either side of the hall. Fluorescent lights rods hang on the ceiling along with two monitors.

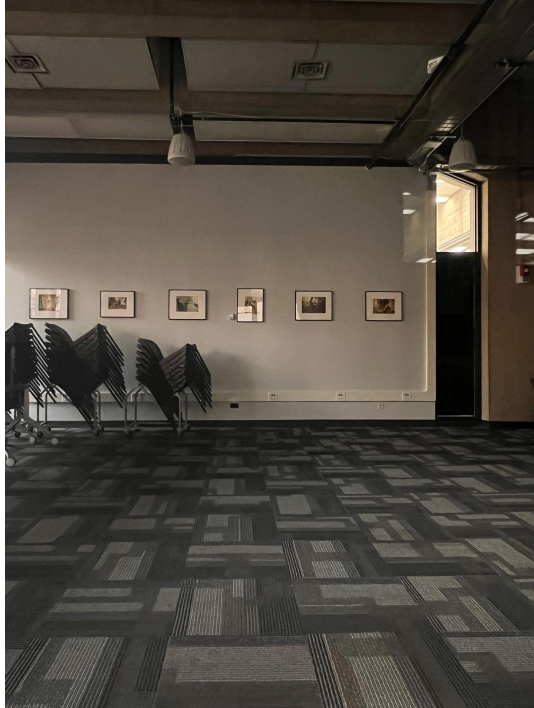
Image Description: Dim spacious hall with carpeted floor throughout. Set of paintings hung onto the walls along with sets of chairs stacked onto one another toward the left side of the image.

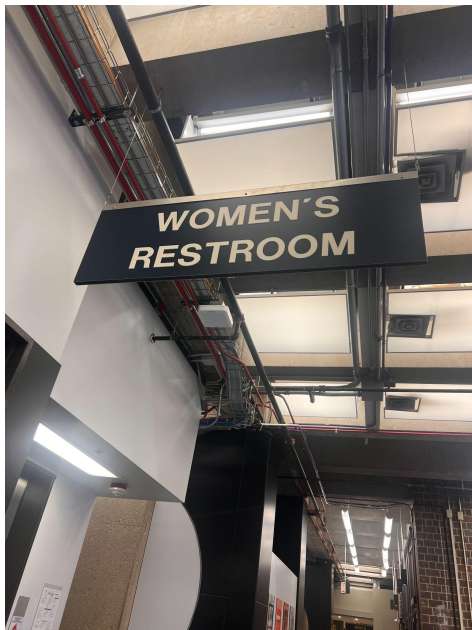
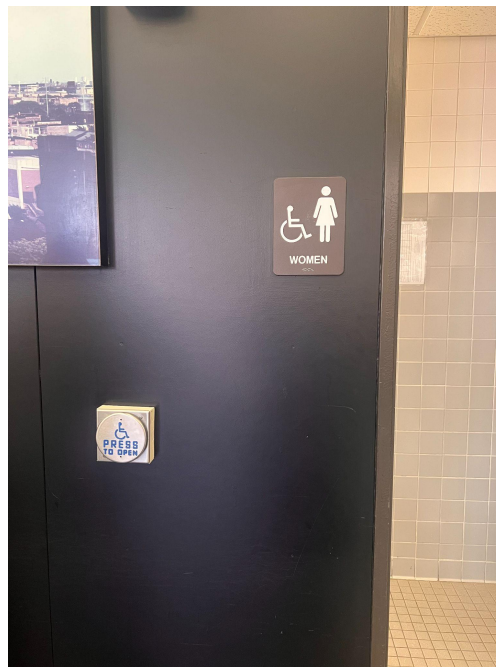
Image Description: (Left) Sign reads “Women’s Restroom” hung from the ceiling. (Right) Women’s restroom sign, accessible with braille, posted beside the entrance, accompanied by the accessibility push button below it.

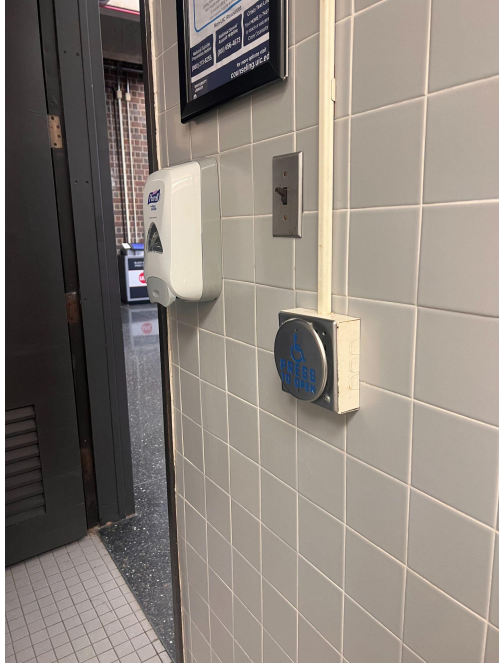
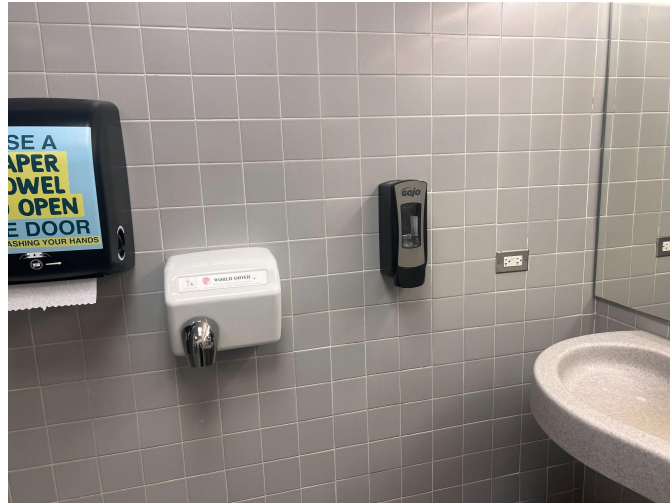
Image Description: (Left) Women's bathroom exit, accessibility push button hung on the tiled wall beside a lightswitch and hand sanitizer dispenser near the exit. (Right) Towel dispenser, drier, and soap dispenser hung on a tiled wall beside a sink.

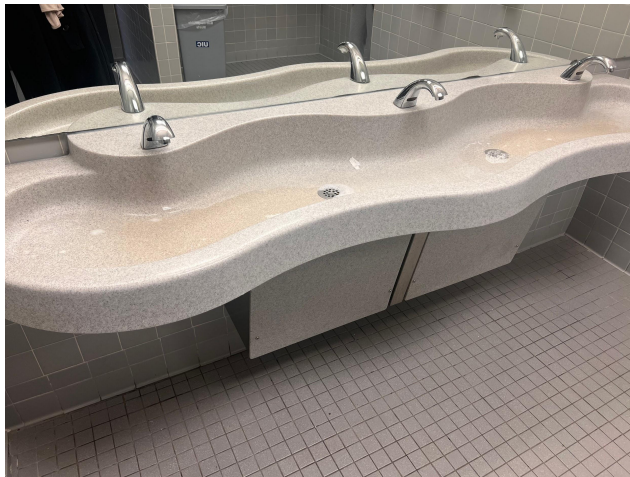
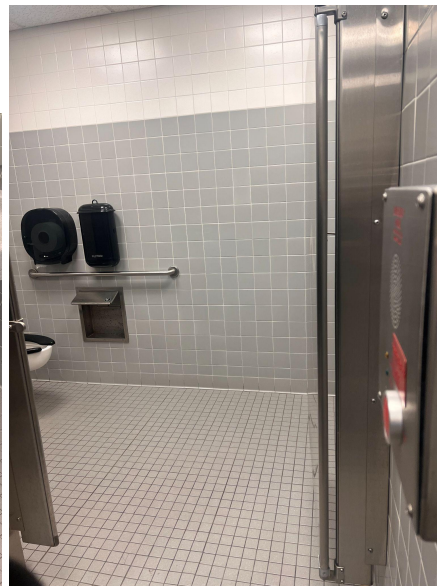
Image Description: (Left) A floating three compartment sink in front of a large mirror, leveled above tiled floors. (Right) Entrance to the accessibility bathroom made of tiled walls and floors. Emergency call button hung to the right of the screen outside the stall. A pull bar, toilet paper dispenser, and trash bin are hung within the stall beside a toilet.

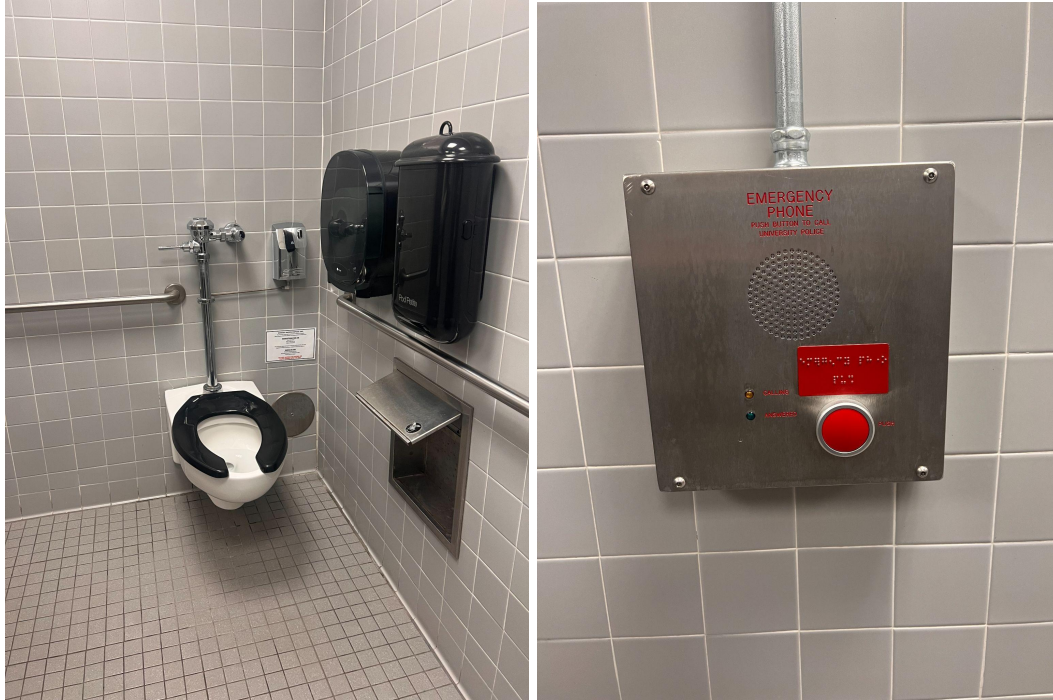
Image Description: (Left) Toilet placed between two pull bars on either side. To the right of the toilet a toilet paper dispenser, and trash bin are propped above the pull bar. The walls and floors are tiled. (Right) Emergency phone and button hung onto a tiled wall.

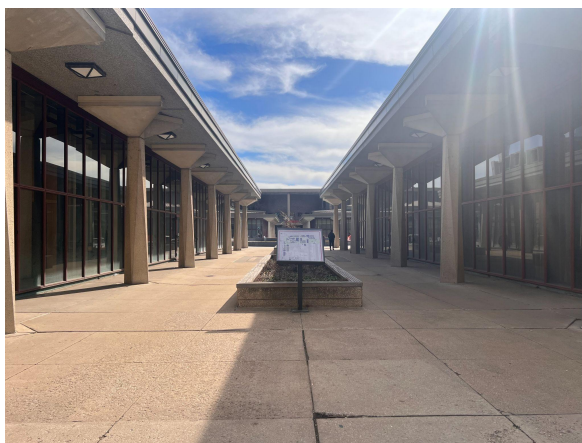
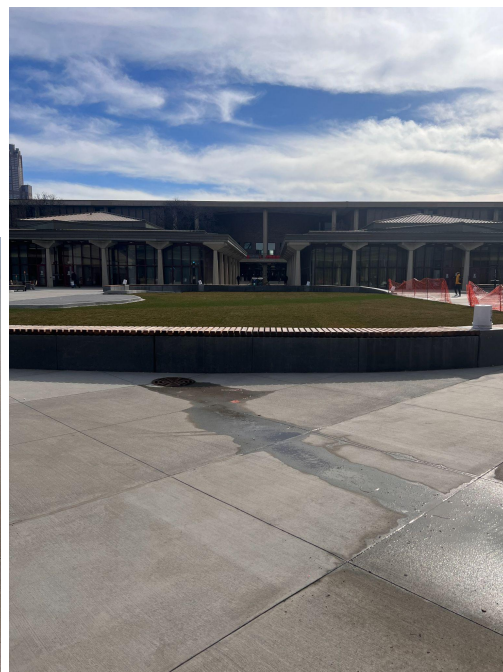
Image Description: (Left) Uneven and cracked concrete alleyway with buildings and polls on either side. A sign in front of an elevated garden is placed within the center of the alleyway. (Right) Wide walkway leading to the Quad. The SCE building is seen far ahead.

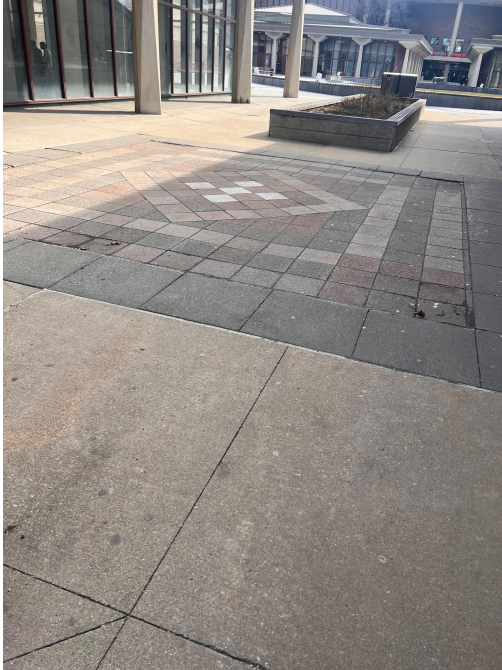
Image Description: Very textured and uneven concrete pattern on an alleyway in front of an elevated garden space. Buildings in the background on the top of the image.
